Lake Miccosukee EcoSummary

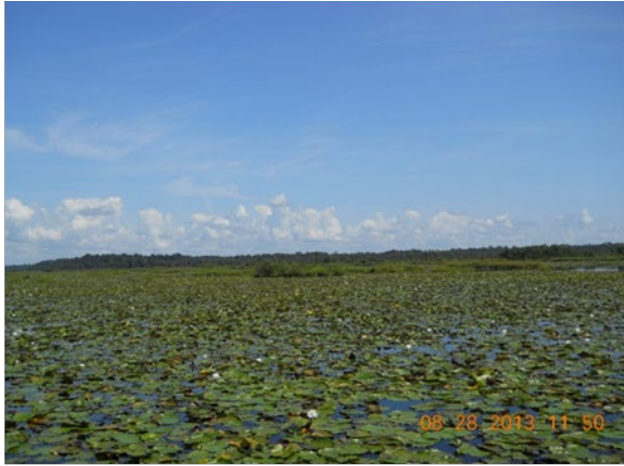
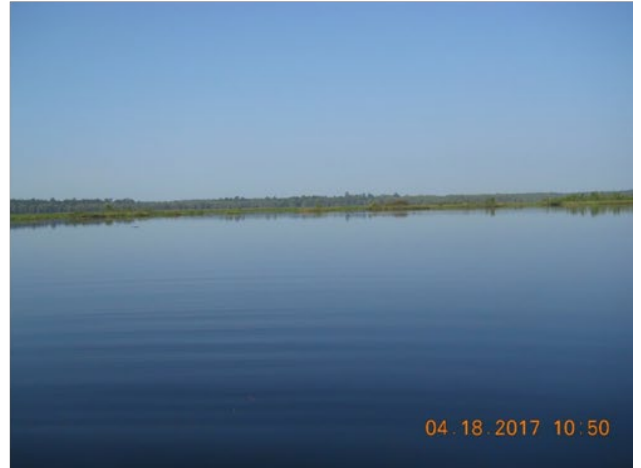
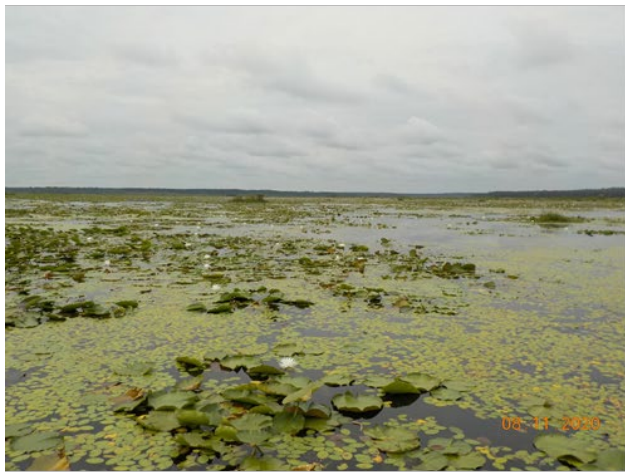
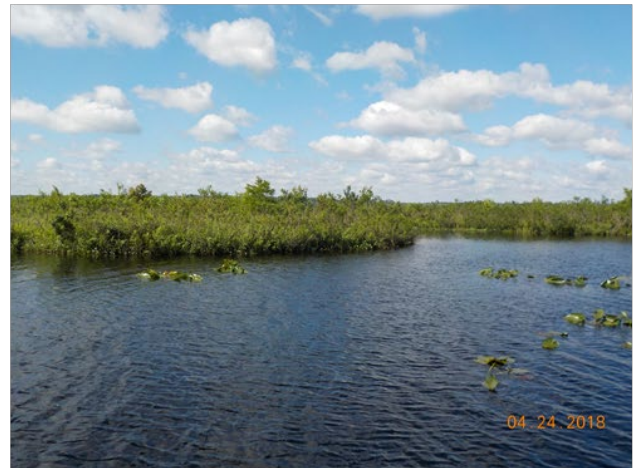
Figure 2. Station MI2 showing the variability of the plant community over time. Photos were taken in: 2013, 2017, 2018, and 2020.

No exceedances were noted, but nutrient levels have fluctuated over time. Changes in the area around the station may have contributed to changes in nutrient concentrations (**Figure 2**). Previously, the area in the vicinity of station MI2 was dominated by *Nymphaea odorata*, the fragrant water lily. Florida Fish and Wildlife (FWC) contractors enlarged an open water area adjacent to the station that had encompassed the station area. More recently, emergent vegetation has again become more dominant, with the

addition of floating tussock islands that have either formed or floated into the sampling area. Because of the anthropogenic disturbances to the vegetative community, fluctuating water chemistry results continue to occur.

As **Figure 3** shows, the Lake Miccosukee stations exhibited percent DO saturation values that did not meet Class III water quality criteria. Staff considers the low DO normal for this lake because the stations are shallow and normally covered with vegetation, preventing rapid water exchange with the larger area of the lake. Plant respiration (samples were often taken in the morning hours) and organic sediments also contributed to the low DO saturation values. Because station MI2 has become less vegetated, more water circulation is occurring along with

less plant respiration, thus allowing DO saturation values to increase.

Based on ongoing sampling, Lake Miccosukee met the nutrient thresholds for the East Panhandle Region. Changes in the plant community are influencing nutrient and percent DO saturation value levels at station MI2. Other water quality parameters appear to be normal for the area and no other impairments were noted.
